## SECTION 5-B

## DYNAFLOW TROUBLE DIAGNOSIS—ADJUSTMENTS ON CAR

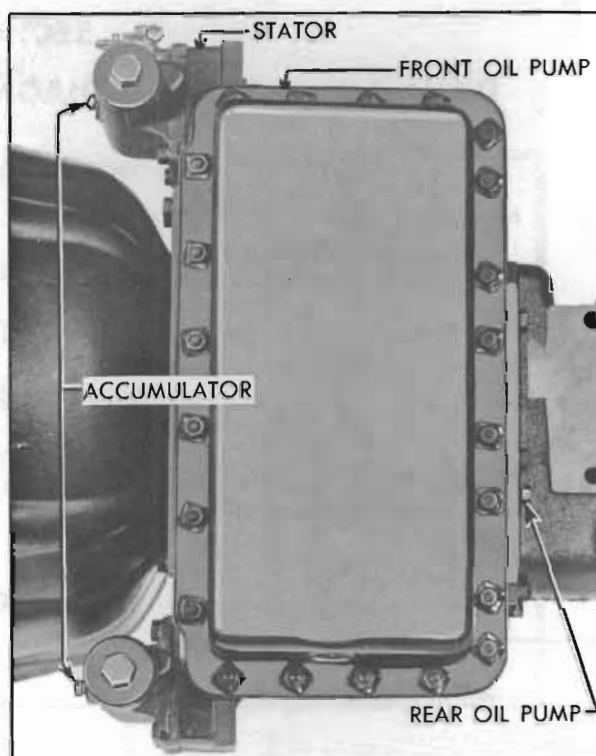
Figure 5-26—Gauge Connections for Oil Pressure Tests

Remove pipe plug at the following points in turn and connect Pressure Gauge J 2575. (1) *Front oil pump*, on left side of transmission case. (2) *Rear oil pump*, in lower flange at front end of rear bearing retainer. (3) *High or low accumulator*, on front upper corner of accumulator body. (4) *Stator*, on left end of reaction shaft flange. See figure 5-26.

Run engine at 500 RPM and test pump and accumulator pressures in Low, Drive and Reverse. Test front oil pump in all ranges and rear oil pump in all but Reverse. Test high accumulator only in Drive and test low accumulator only in Low. Repeat tests at 1000 RPM and 1800 RPM in Low and Drive only. The following pressures should be obtained on these tests.

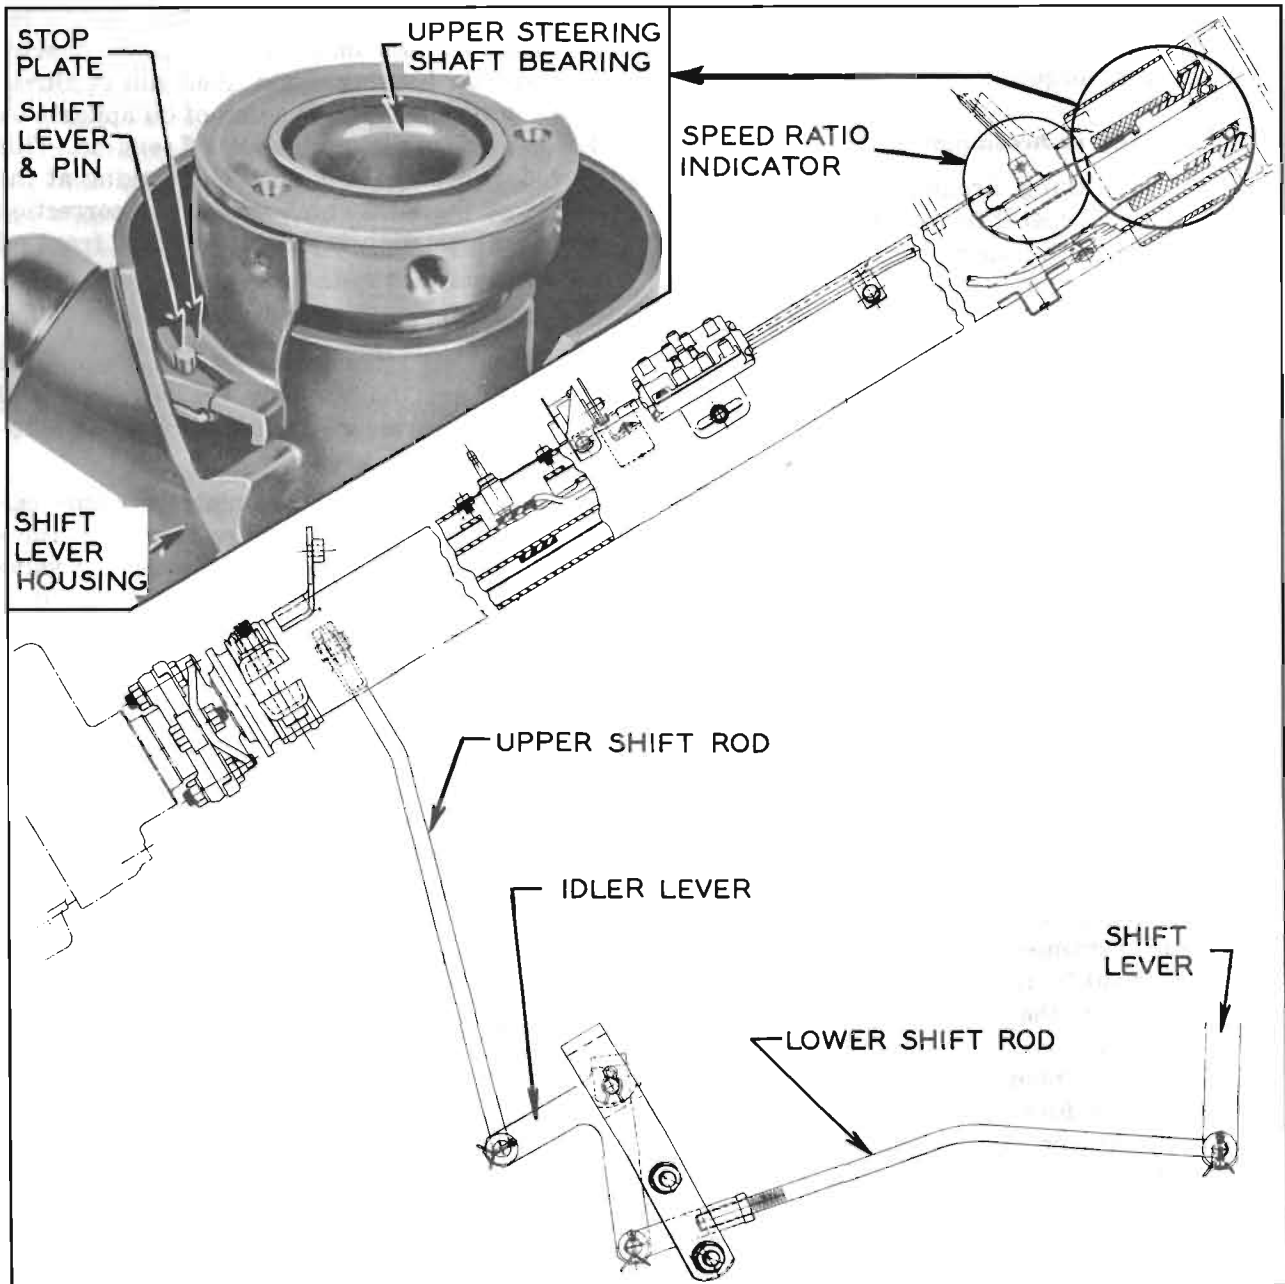
Figure 5-27—Shift Linkage, Lever and Stop Plate

The shift control lever mounted in the housing at upper end of steering column jacket operates a tubular control shaft located inside the column jacket. When the lever is pulled upward toward the steering wheel the lever stop pin is disengaged from a stop plate in the shift lever housing. The control shaft can then be rotated by movement of the control lever. The control shaft lower lever operates the transmission shift lever through connecting rods and an idler lever mounted on car frame.

The shift lever operates a cross shaft inside the rear bearing retainer, from which linkages connect to the shift control valve and the parking lock pawl. A spring loaded detent lever and roller engages notches in a detent plate on the cross shaft to hold the control valve in any set position.
