GROUP 12 SHEET METAL

12-1 DESCRIPTION OF SHEET METAL

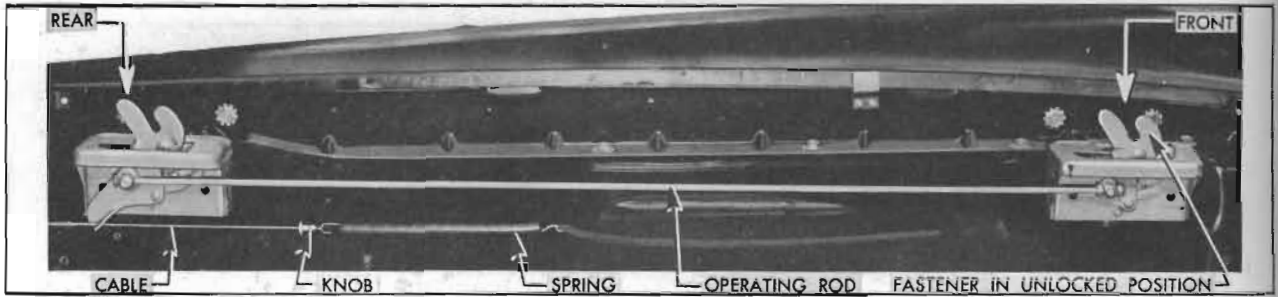
The hood fastener mechanism is incorporated in the hood hinges. A hood fastener mounted in each hinge engages the hood reinforcement pilot

Figure 12-1—Hood Hinges and Fastener Mechanism

plate when hood is lowered, and as side of hood is pressed down the fasteners rotate to securely lock the hood to the hinges. A pilot pin on reinforcement pilot plate engages a hole in each hinge pilot plate to hold the hood in proper relation to fenders and cowl.

When either side of hood is to be unlocked the hood fastener mechanism is operated by a cable attached to a control knob located inside the body at lower edge of instrument panel. The forward end of release cable is connected to a coil spring attached to fender skirt; the spring holds the cable and knob in forward position. When knob is pulled rearward to unlock hood, a knob on end of cable pushes against an arm of rear hinge fastener to rotate fastener to the unlocked position. The front hinge fastener is rotated to unlocked position by a rod which connects the front and rear fasteners. See figure 12-1.

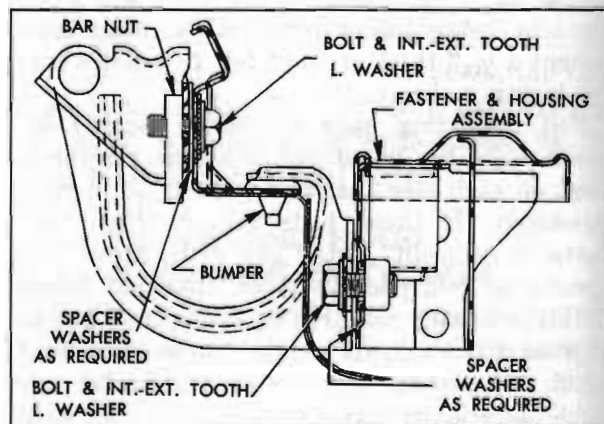
The hinge fastener and housing assembly is bolted to the gooseneck hinge strap and the bolt holes in strap are slotted to permit vertical adjustment of the fastener housing only. See figure 12-2. This arrangement permits vertical adjustment without changing the pivot point of the hinge, and without changing the fore and aft setting.

Figure 12-2—Hood Hinge Mounting

Lateral adjustment of hinge to change hood-to-fender clearance is obtained by U-shaped spacer washers which can be removed or installed without removing hinge bolts. These washers are furnished under Group 8.014 in thicknesses of .030" and .120".

To move hinge fastener and housing assembly outward to decrease hood-to-fender clearance, either remove spacer washers from between fastener housing and hinge strap or install washers between hinge mounting bracket and fender rail. To move parts inward to increase clearance, either remove spacer washers from between hinge mounting bracket and fender rail or install washers between hinge strap and fastener housing. See figure 12-2. An equal total thickness of washers must be used on both bolts at either point of adjustment.

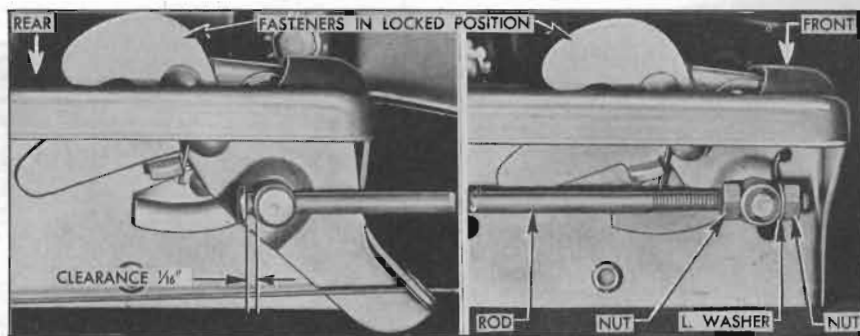
Figure 12-3—Adjustment of Hood Fastener Operating Rod

with holes in hinge pilot plates. Push both fasteners down to the locked position and have both hinges resting on bumpers on fender rail. Check the clearance between the shoulder on rear end of operating rod and the trunnion of rear fastener; clearance should be approximately $\frac{1}{16}$ ". Adjust the nuts on each side of front fastener trunnion to obtain this clearance, if necessary. See figure 12-3.

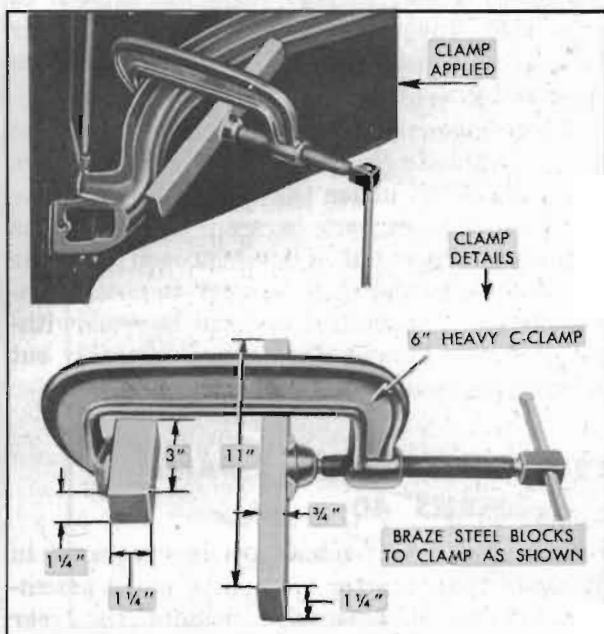
Figure 12-4—Straightening Hood Panel Reinforcement to Spread Hood

The hood may be made wider by straightening the reinforcement with a C-clamp prepared and applied as shown in figure 12-4. The hood may be reduced in width by bending the reinforcement with a large turnbuckle prepared and applied as shown in figure 12-5. Both tools illustrated may be made locally from details shown.

The hood panel reinforcements are of channel section and welded to hood side rails to provide an assembly of fixed width at all points. Adjustment for width should not be necessary except when hood has been distorted due to accident. If alteration of hood width becomes necessary,

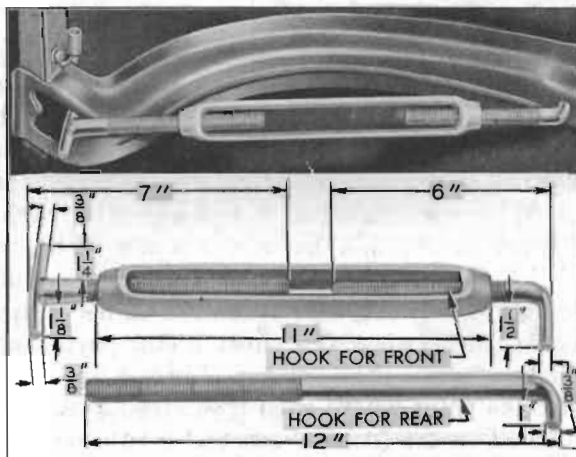
Figure 12-5—Bending Hood Panel Reinforcement to Reduce Hood Width

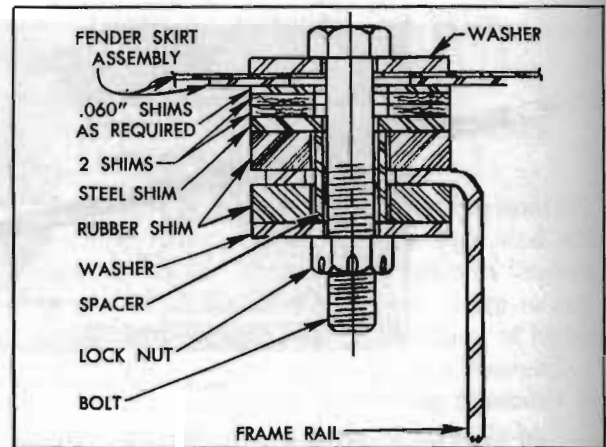
At the point where each front fender skirt is attached to the frame front end a rubber shim is placed on each side of the frame rail top flange, with a steel washer, $\frac{1}{8}$ " steel shim and

Figure 12-6—Fender Skirt Bolt and Shims

tubular spacer placed to control compression of the rubber shims as the bolt is tightened. Two steelbestos shims are placed between the $\frac{1}{8}$ " steel shim and the fender skirt. When additional shimming is required one or more extra steel shims .060" thick are placed between the steelbestos shims and the fender skirt. See figure 12-6.

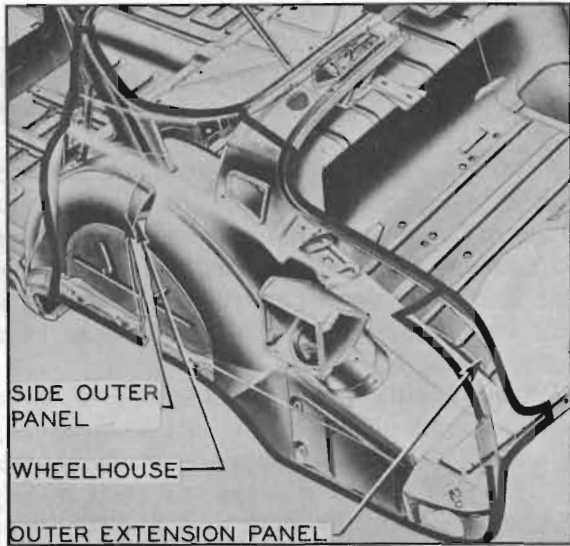
Series 40 rear fenders are incorporated in the body rear quarter side outer panel assemblies. A panel assembly includes the rear quarter side outer panel, wheelhouse, gas tank filler cover (left side), side outer extension

Figure 12-7—Rear Quarter Side Outer Panel Assembly—
Series 40

panel, and miscellaneous small parts all welded together. See figure 12-7.

The rear quarter side outer panel does not include the area covered by the side outer extension panel shown in figure 12-7. The extension panel is also available for service replacement.

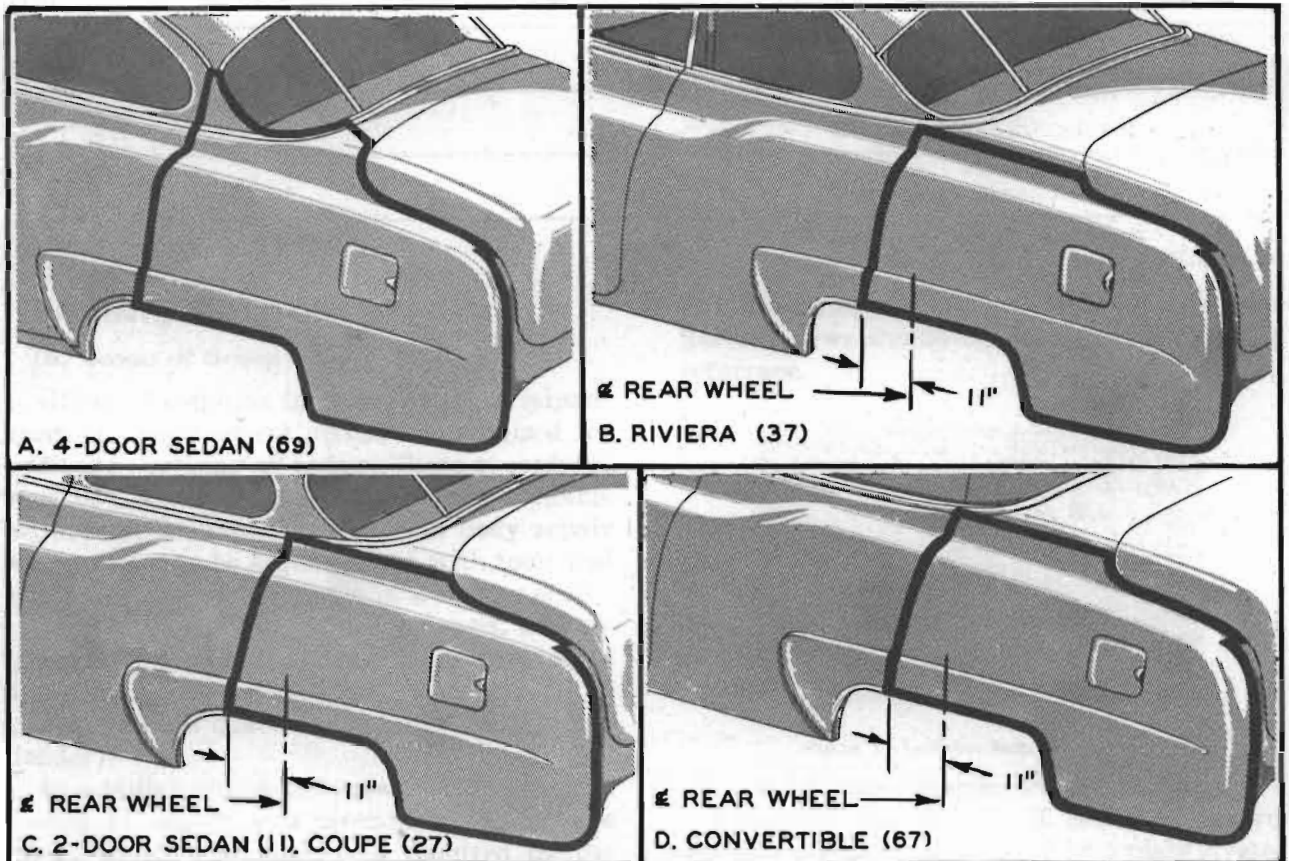
Figure 12-8—Four-Door Rear Quarter Side Outer Panel Application to Two-Door Models

The 4-door sedan (Style 69) rear quarter side outer panel is the most economical panel to use for replacement in the indicated area on any model. This panel is shown in figure 12-8, view A. Views B, C and D show the application of the interchangeable portion of this panel to the 2-door models. It is not necessary to replace the entire area indicated—only the damaged area need be replaced.

From lower edge to crown and to a vertical line approximately 11" forward of rear wheel centerline the contours of all Series 40 rear quarter side outer panels are identical. A section cut from this area of any available

outer panel may be used for replacement of the corresponding section of panel on any *Series 40* model.
