SECTION 7-D FOLDING TOP ADJUSTMENTS

7-7 DESCRIPTION

7-8 TOP ADJUSTMENTS

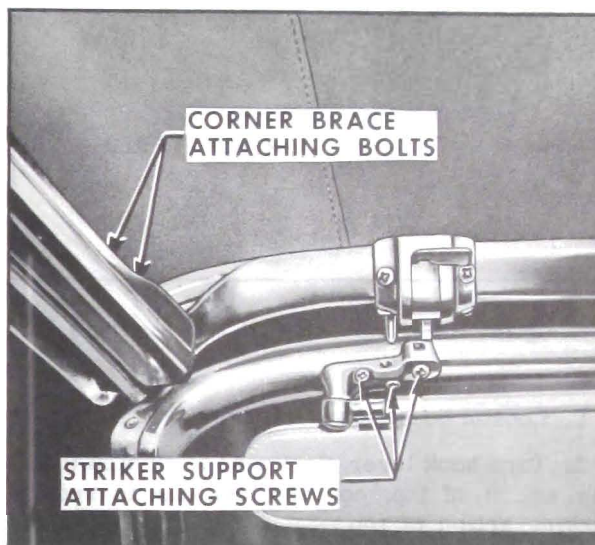
2. Loosen corner brace attaching bolts (Figure 7-18) and adjust front roof rail fore or aft as required. Repeat on opposite side if necessary.

Figure 7-18—Front Roof Rail Adjustment

2. Loosen striker support attaching screws (Figure 7-18) and adjust striker as required; then tighten attaching screws.

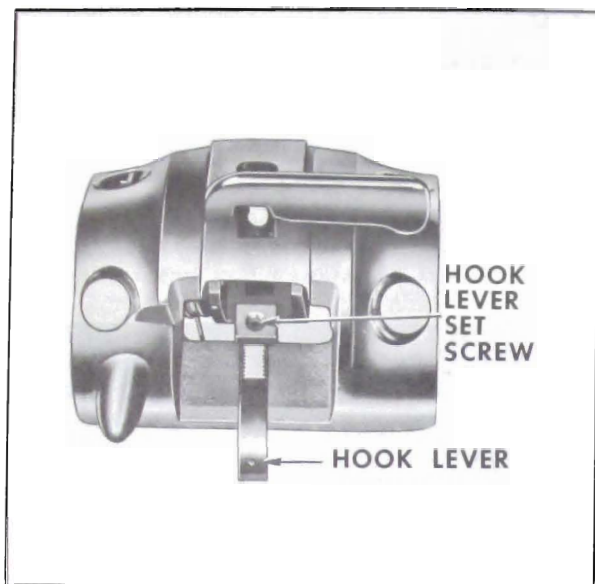
Figure 7-19—Front Roof Rail Lock Assembly

1. Loosen hook lever set screw (Figure 7-19).
2. Turn hook lever clockwise to tighten locking action of top, counterclockwise to reduce locking action of top.
3. After desired locking action has been obtained, tighten hook lever set screw.

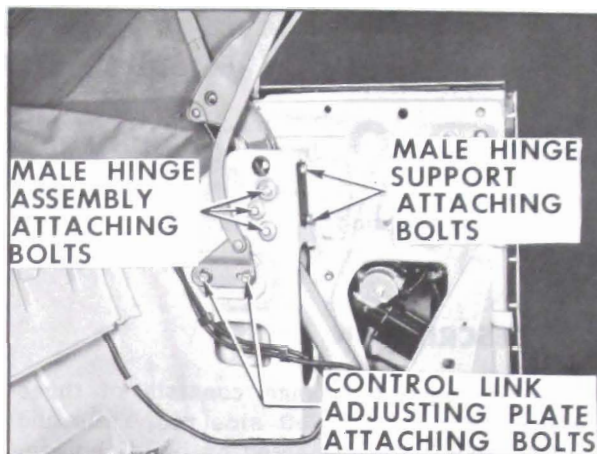
1. With top in up position, if joint between front and center side roof rail is too high or too low, proceed as follows:
 - a. Remove folding top compartment side trim panel and loosen two bolts securing control link adjusting plate (Figure 7-20) sufficiently to permit adjustment of plate.
 - b. Without changing fore and aft location of adjusting plate, adjust side roof rail up or down allowing adjusting plate to move up or down over serrations on support as required; then tighten bolts.
2. If top assembly does not stack properly when top is in down position, proceed as follows:
 - a. Loosen bolts securing control link adjusting plate sufficiently to permit adjustment of plate.
 - b. Without changing the up or down location of adjusting plate, move adjusting plate forward

Figure 7-20—Folding Top Adjustment

1. If there is an excessive opening between side roof rail rear weatherstrip and rear of rear quarter window, or if front roof rail is too far forward or rearward, proceed as follows:
 - a. Loosen three male hinge assembly attaching bolts (Figure 7-20).
 - b. Move hinge fore or aft as required to obtain proper alignment between side roof rail rear weatherstrip and rear quarter window; then tighten bolts.
 - c. Lock front roof rail to windshield (where required, adjust front roof rail corner brace as previously described), and check fit of top material at rear quarter trim stick area. If necessary, adjust trim stick; then tighten trim stick attaching bolts.

b. Loosen male hinge assembly attaching bolts and male hinge support front attaching bolts (Figure 7-20).

d. Tighten hinge support front attaching bolts, then while maintaining proper alignment of scribe marks on top of hinge, tighten hinge assembly attaching bolts (Figure 7-20).
