SECTION 5-B

VARIABLE PITCH DYNAFLOW TROUBLE DIAGNOSIS—
ADJUSTMENTS ON CAR

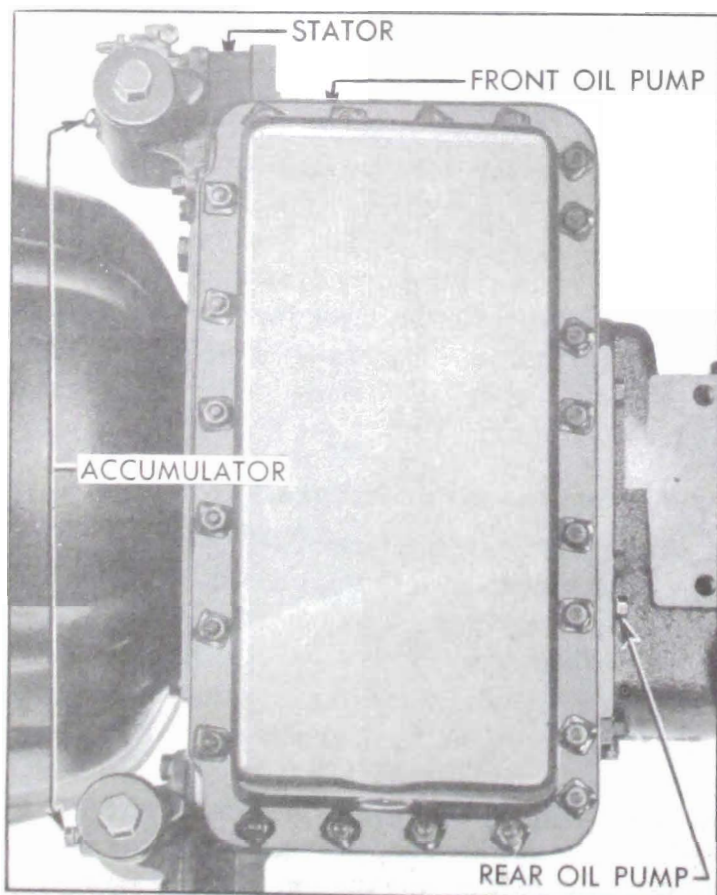
Figure 5-26—Gauge Connections for Oil Pressure Tests

Remove pipe plug at the following points in turn and connect Pressure Gauge J 2575. (1) *Front oil pump*, on left side of transmission case. (2) *Rear oil pump*, in lower flange at front end of rear bearing retainer. (3) *High or low accumulator*, on front upper corner of accumulator body. (4) *Stator*, on left end of reaction shaft flange. See figure 5-26.

Run engine at 500 RPM and test pump and accumulator pressures in Low, Drive and Reverse. Test front oil pump in all ranges and rear oil pump in all but Reverse. Test high accumulator only in Drive and test low accumulator only in Low. Repeat tests at 1000 RPM and 1800 RPM in Low and Drive only. The following pressures should be obtained on these tests.

| Engine RPM | Trans. Range | Front Pump | Rear Pump | Accumulator | Stator (min.) |

Low or erratic oil pump pressure indicates an air leak into the pump suction line, faulty pressure regulator valve operation, or excessive clearance in pump. Low rear pump pressure also may be caused by a leak in the valve and servo body passages which connect the rear pump with the pressure regulator valve. If pressure of one pump is low but pressure of other pump is satisfactory, air leaks into suction lines are possible causes. However, faulty pressure regulator valve is eliminated as possible cause since the same valve regulates pressure of both pumps.

Very low accumulator pressure may be caused by external or internal leakage past the accumulator body gasket. A difference of more than 10 psi between front pump and an accumulator indicates an excessive leak between the accumulator and the clutch (if high accumulator pressure is low) or the low servo (if low accumulator pressure is low), or else the metering orifice in accumulator is restricted or plugged.

Low pressure at high accumulator may also be caused by the stator oil circuit. Disconnect control rod from lever on accumulator, make certain that lever is properly positioned and tight on valve crank, then raise lever against its stop while noting gauge reading. A rise in pressure indicates a leak in the stator control circuit.

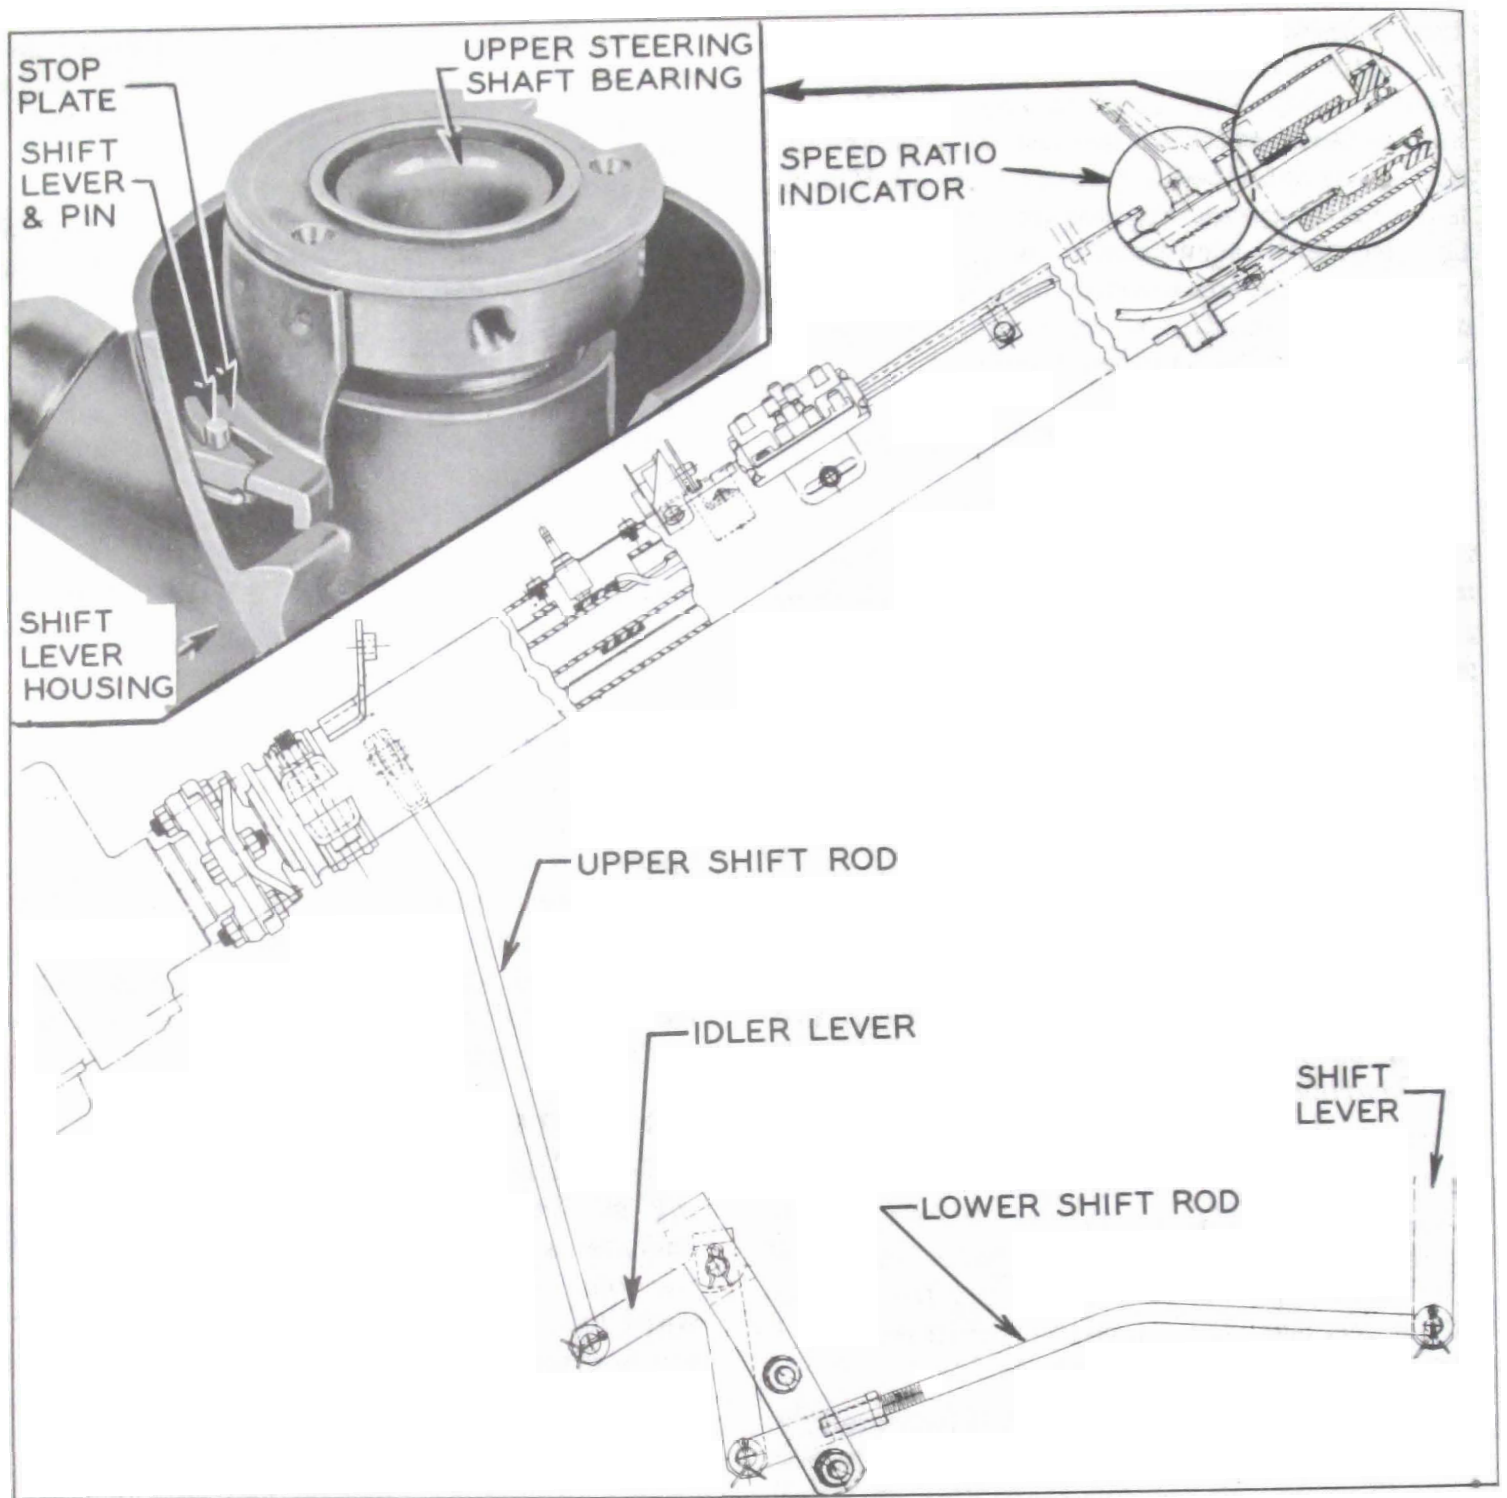
Figure 5-27—Shift Linkage, Lever and Stop Plate

When a Dynaflo transmission does not operate properly it is advisable to first check the shift control linkage adjustment, *after checking to be sure oil is at proper level.* The

shift control linkage may be easily checked as follows:

1. With manual control lever left in Drive, raise car to get at linkage adjusting clevis on lower shift rod.
2. Loosen clevis lock nut. Remove clevis pin along with cotter key and spring washer.
