SECTION D

49000 PROPELLER SHAFT

41-12 DESCRIPTION OF PROPELLER SHAFT

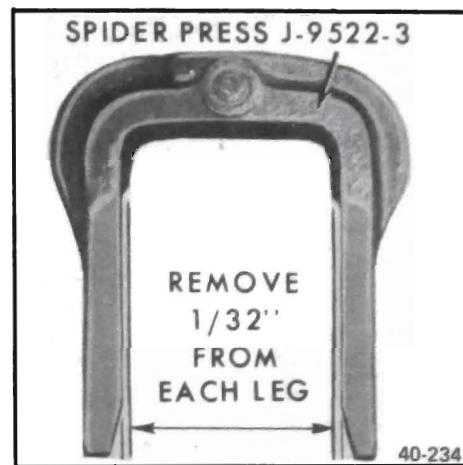
Figure 40-70 - Spider Press Leg Rework

NOTE: Remove 1/32" of stock from inside each leg of spider press J-9522-3 which will allow the spider press legs to straddle the CV yokes. See Figure 40-70.
