# SECTION C

## 43-44-45-46-48000 PROPELLER SHAFT

## 4I-2 DESCRIPTION OF PROPELLER SHAFT

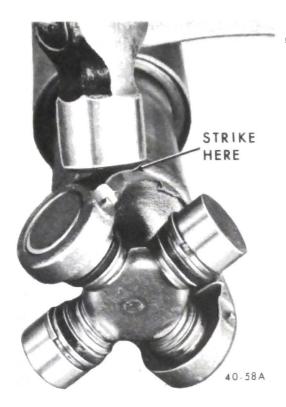
Figure 40-53 Seating U-joint Snap Rings

- 3. While observing the previous precautions, install the balance of the bearings necessary to complete the assembly and install snap rings.
- 4. Strike the yoke firmly with a hammer to fully seat the snap rings against the yoke. Turn the spider to make certain that it is free. See Figure 40-53.

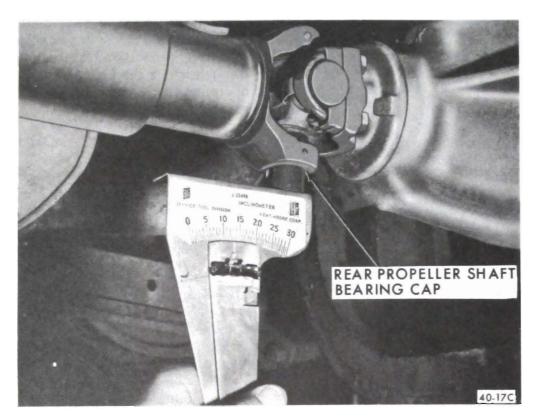
Figure 40-57 Measuring Angle at Rear of Propeller Shaft

l. Place inclinometer on rear propeller shaft bearing cap. See Figure 40-57. Center bubble in sight glass and record measurement.

- CAUTION: Bearing cap must be straight up and down and free of dirt or other foreign material to obtain an accurate measurement.
- 2. Rotate propeller shaft 90° and place inclinometer on rear drive yoke bearing cap. See Figure 40-58. Center bubble in sight glass and record measurement.
- 3. Subtract smaller figure from larger figure to obtain existing rear universal joint angle.
- 4. Place inclinometer on front propeller shaft bearing cap. See Figure 40-60. Center bubble in sight and record measurement.
- 5. Rotate propeller shaft 90° and place inclinometer on front slip spline yoke bearing car. See Figure 40-61. Center bubble on sight glass and record measurement.
- 6. Subtract smaller figure from larger figure to obtain existing front universal joint angle.
