SECTION C

PROPELLER SHAFT

ALL SERIES

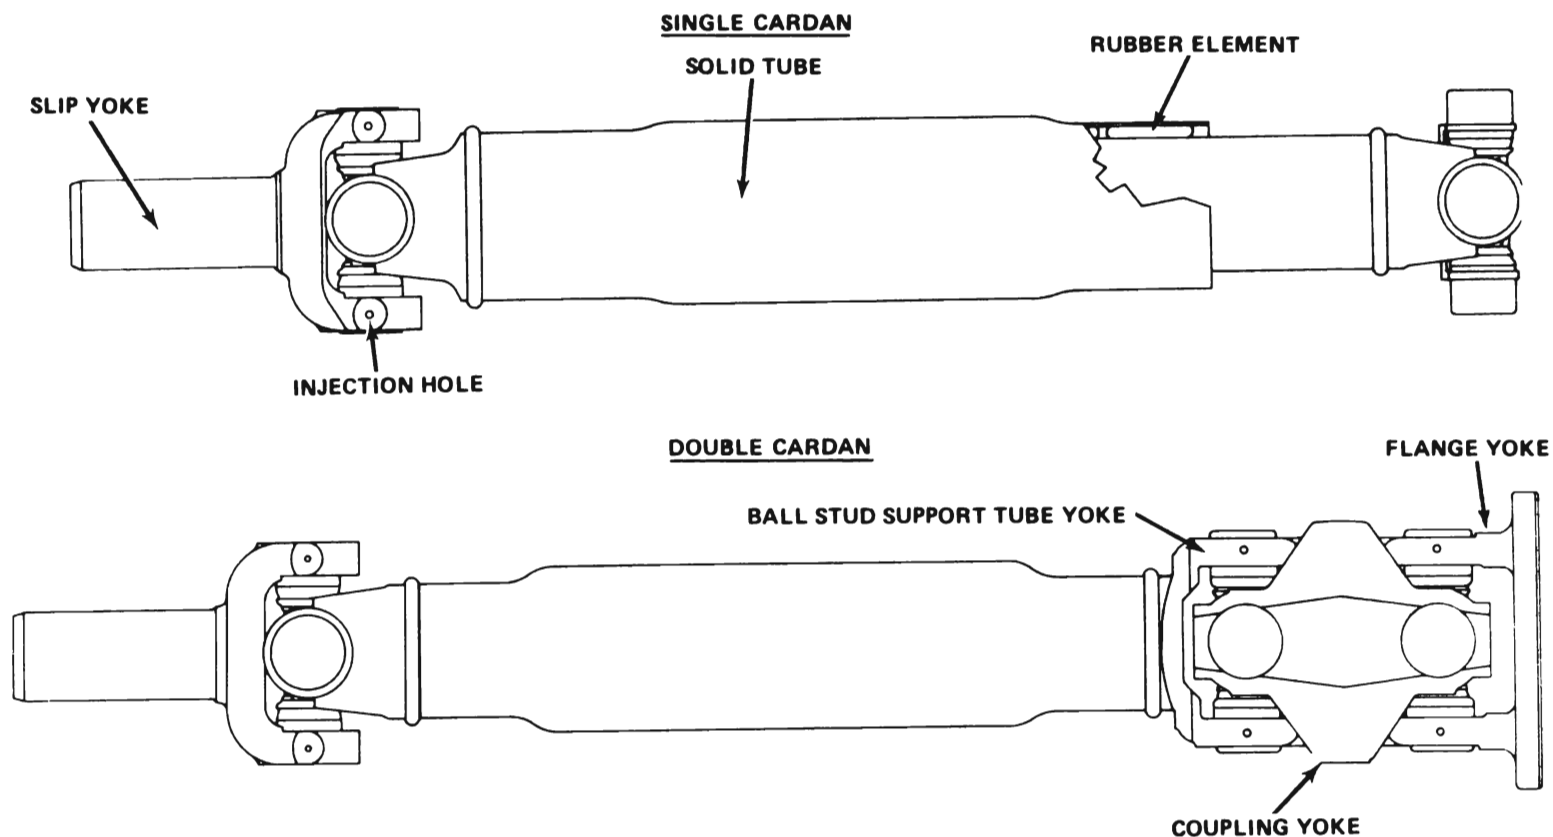
Figure 40-49 - Propeller Shaft Assemblies

Power is transmitted from the transmission output shaft to the differential by either one of two type propeller shaft assemblies: One type used on the 4D-4F-4G-4H and Estate Wagons is a one-piece shaft with two cardan universal joints. The other type used on 4L-4N-4R-4P-4U-4V-4Y (less Estate Wagons) also has a one-piece propeller shaft but has a cardan universal

joint in the front and a double cardan universal joint at the rear. See Figure 40-49.

The propeller shaft used on 4D-4F-4G-4H and Estate Wagons is made up of concentric steel tubes with rubber elements between. See Figure 40-49.

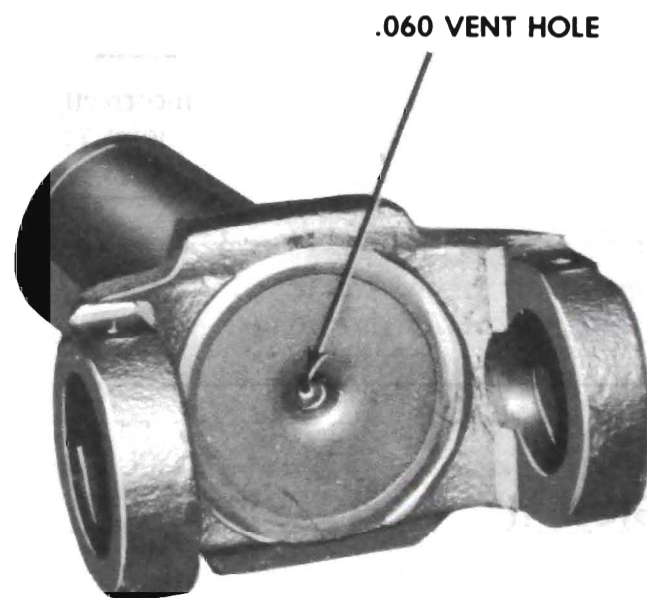
Figure 40-50 Slip Yoke With Vent Axle

seal at the transmission prevents leakage and protects the slip yoke from dust, dirt, and other harmful material. On cars with automatic transmissions, the slip yoke spline is lubricated with grease and provided with a small vent hole to prevent "blowing" the O-ring seal during installation. These slip yokes should be inspected to be sure the vent hole is clear. See Figure 40-50.

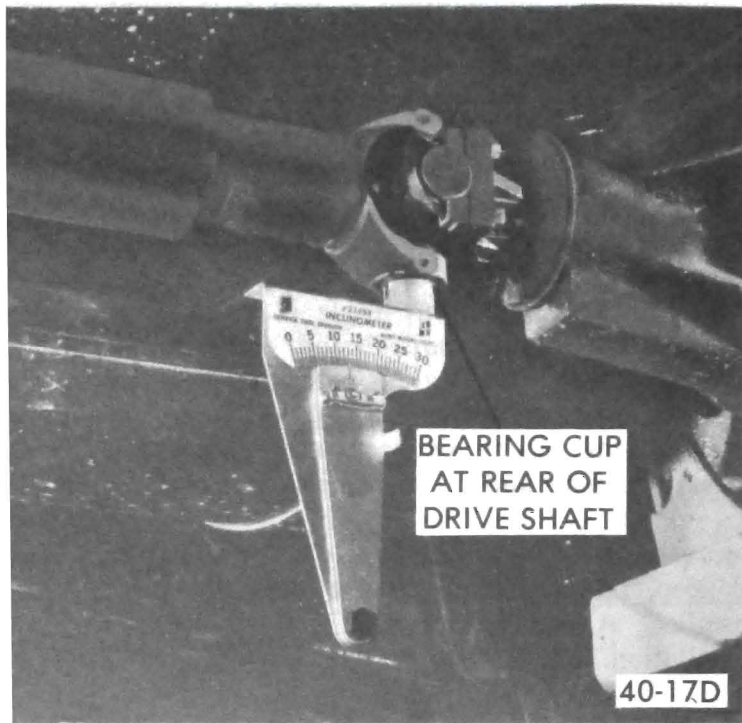
Figure 40-51 Measuring Angle at Rear of Propeller Shaft

1. Place inclinometer on rear propeller shaft bearing cap. See Figure 40-51. Center bubble in sight glass and record measurement. Bearing cap must be straight up and down and free of dirt or other foreign material to obtain an accurate measurement.

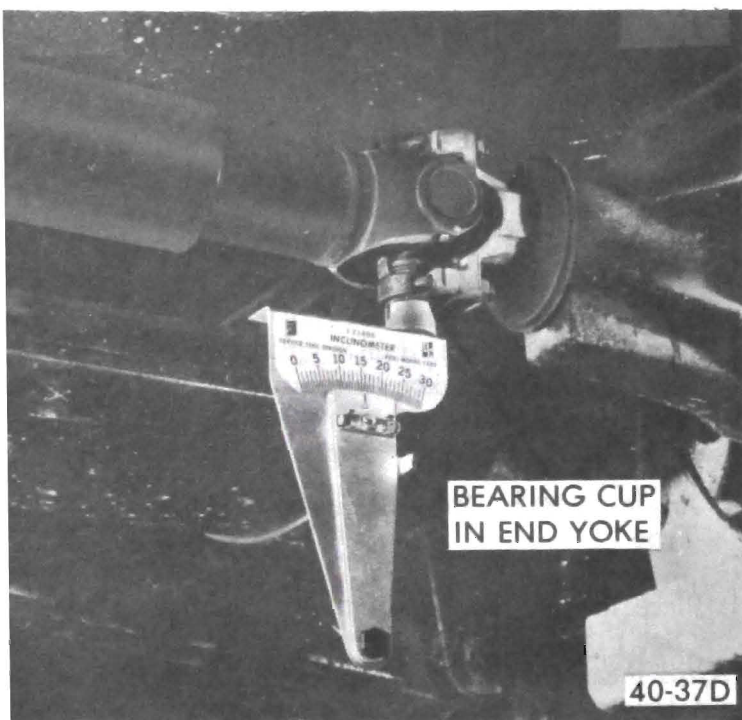
Figure 40-52 Measuring Angle at Rear of Propeller Shaft

2. Rotate propeller shaft 90 degrees and place inclinometer on rear drive yoke bearing cap. See

Figure 40-52. Center bubble in sight glass and record measurement.

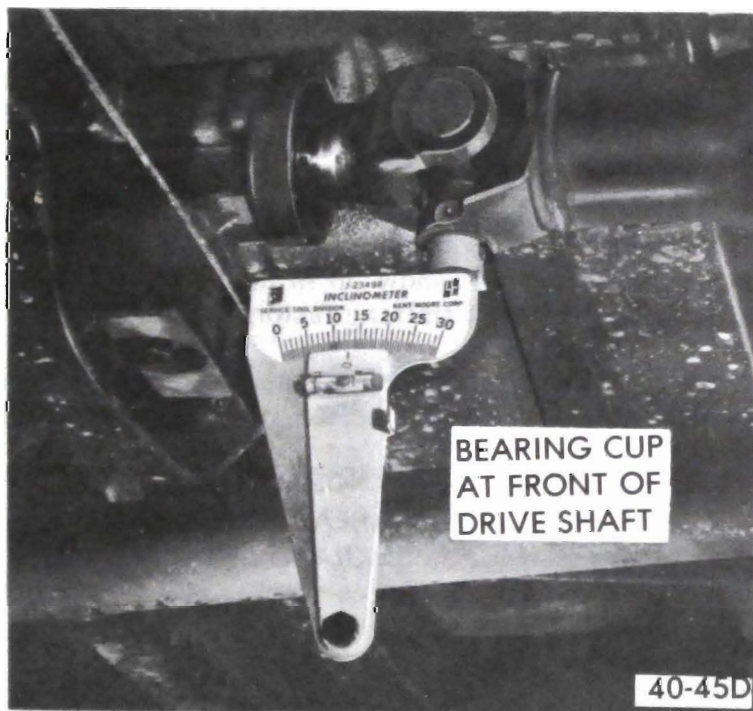
Figure 40-54 Measuring Angle at Front or Propeller Shaft

1. Place inclinometer on front propeller shaft bearing cap. See Figure 40-54. Center bubble in sight and record measurement.

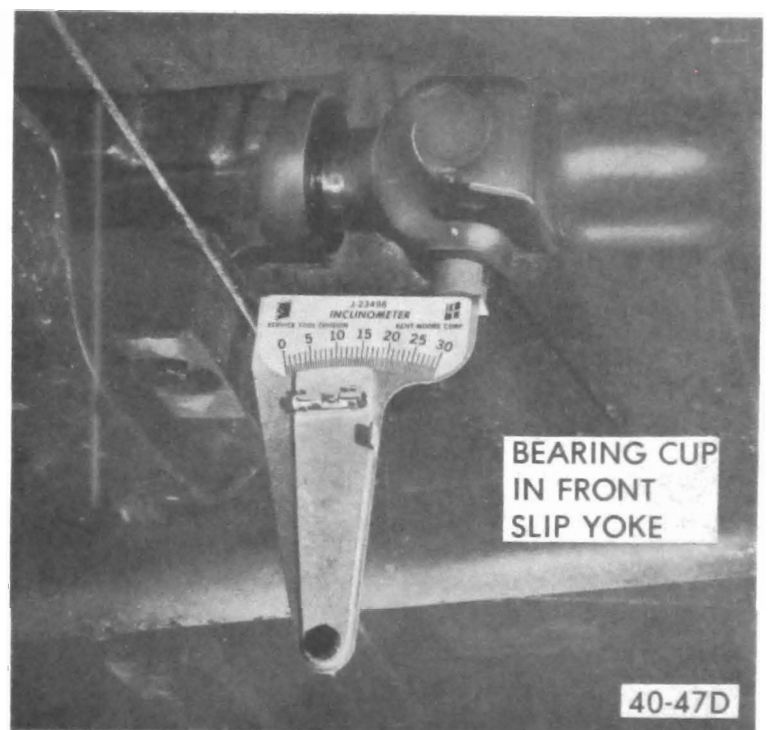
Figure 40-55 Measuring Angle at Front of Propeller Shaft

2. Rotate propeller shaft 90 degrees and place inclinometer on front slip spline yoke bearing cap. See Figure 40-55. Center bubble on sight glass and record measurement.

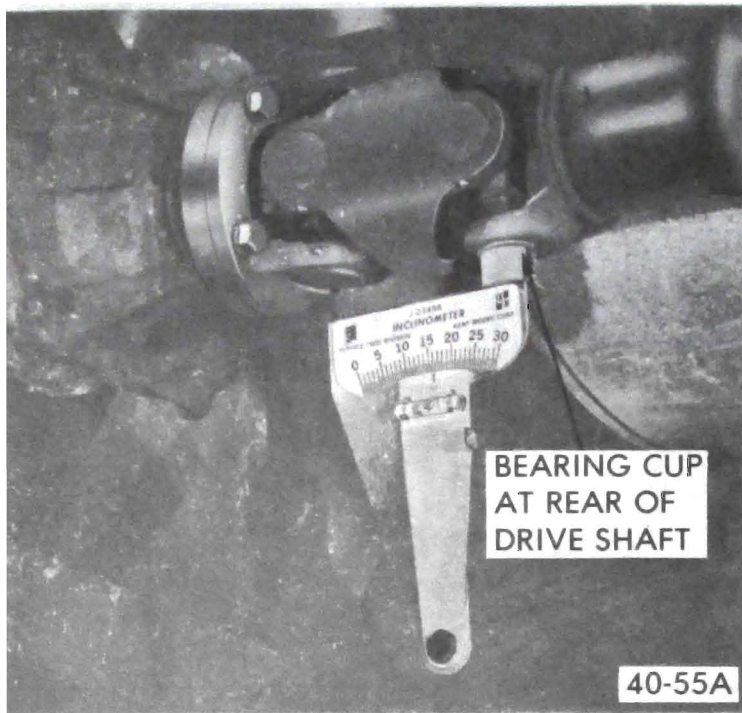
Figure 40-55A - Measuring Angle at Rear of Propeller Shaft

1. Place inclinometer on rear drive shaft bearing cup. See Figure 40-55A. Center bubble in sight glass and record angle.

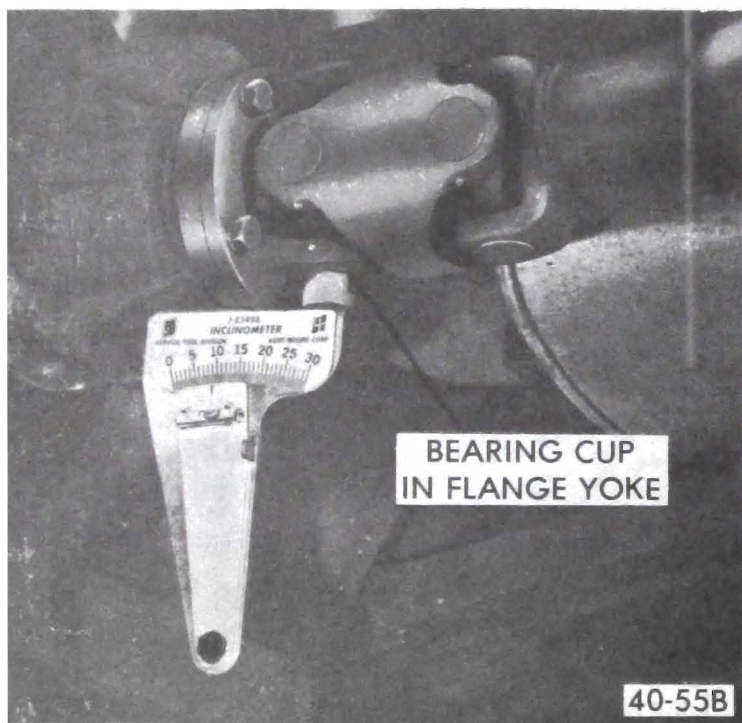
Figure 40-55B - Measuring Angle at Rear of Propeller Shaft

2. Place inclinometer on rear flange yoke bearing cup. See Figure 40-55B. Center bubble in sight glass and record angle.

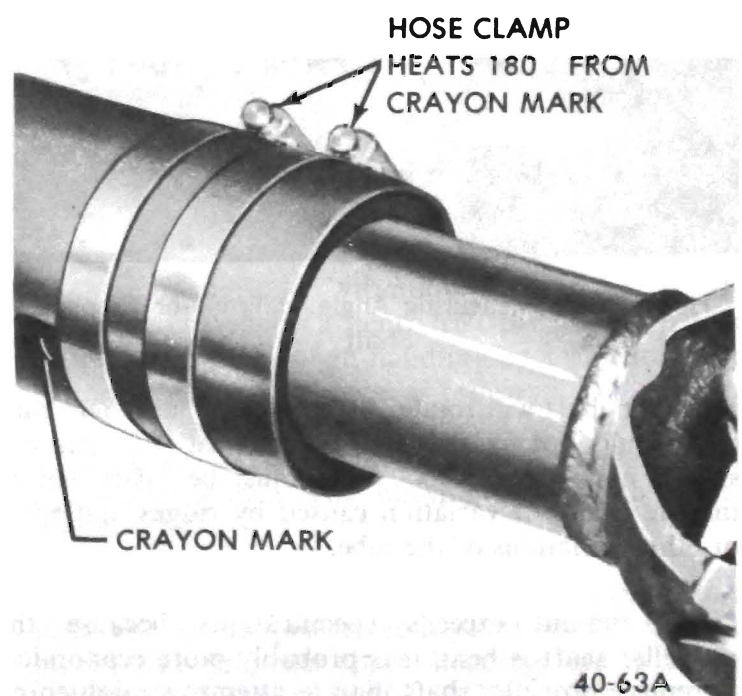
Figure 40-56 - Balance Hose Clamps in Place

3. Install two (2) Wittek type hose clamps on the rear propeller shaft and slide them rearward until the clamps stop at the nearest balance weight welded to the tube. Align both clamps to any one of the four marks made on shaft in Step 2. Tighten the clamps. See Figure 40-56. Be sure sufficient clearance is maintained so that clamp heads do not contact floor pan of car when axle is in contact with rebound bumper in frame. In order to gain sufficient clearance, it may be

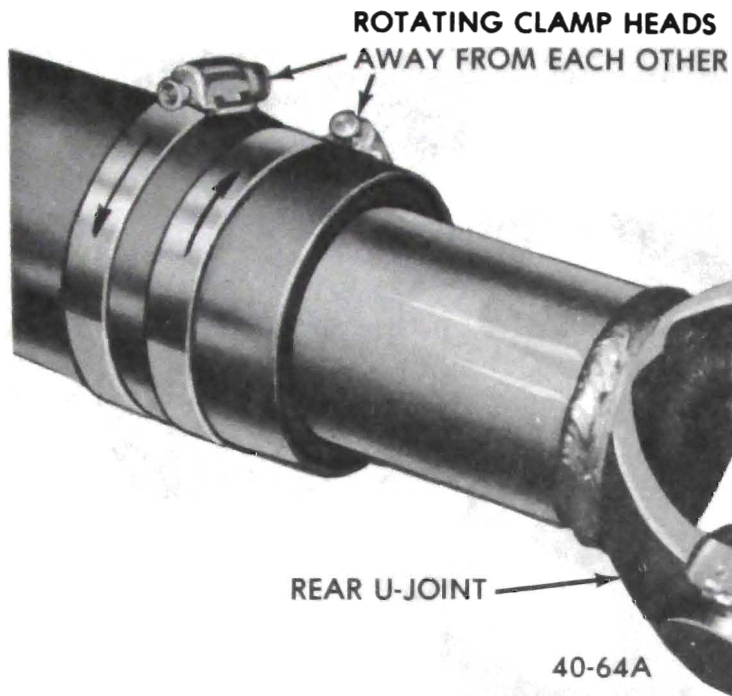
Figure 40-57 - Rotating Balance Hose Clamps

5. Loosen clamps and rotate clamp heads 90 degrees to the next mark on shaft. Tighten clamps and repeat Step 4.

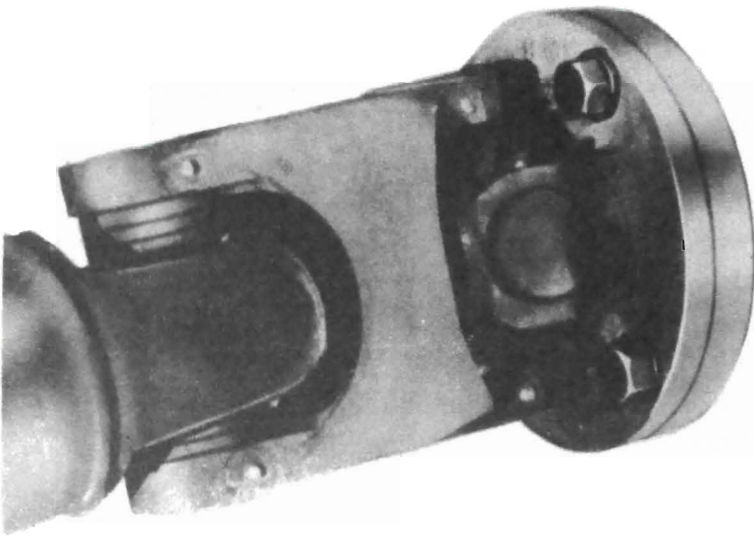
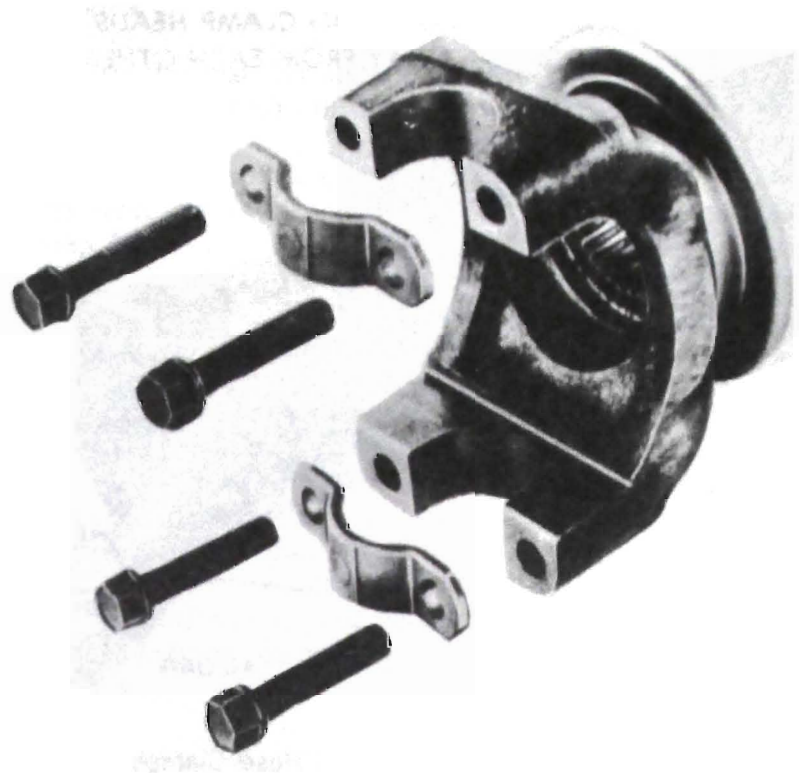
Figure 40-58 - Rear Propeller Shaft Attachments

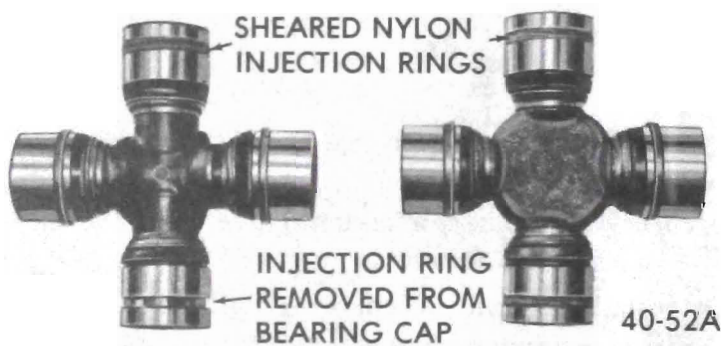
Figure 40-59 - Production Universal Joints

When disassembling a propeller shaft, one or both of the two types of universal joints, as shown in Figure 40-59, may be found.

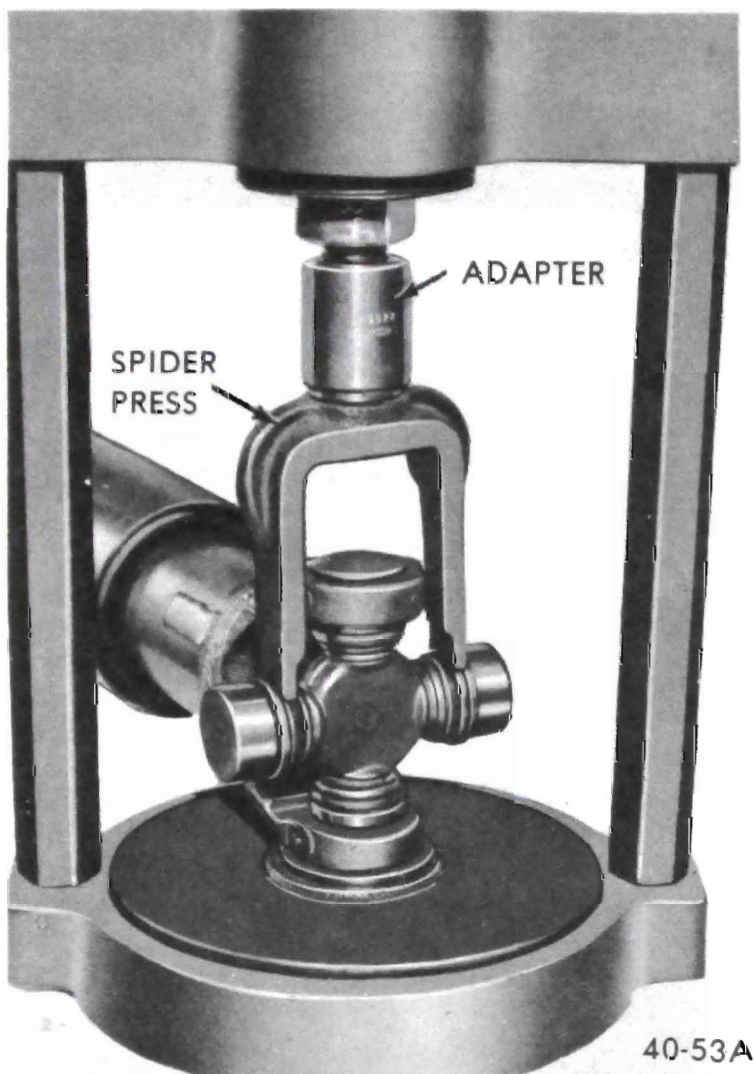
Figure 40-60 - Pressing Out U-Joint Bearing

1. Support the propeller shaft in a horizontal position in line with the base plate of a hydraulic press. The bearing cups should be removed in the order indicated in Figure 40-62. This method requires the least work to get to the heart of the centering ball system where the most critical

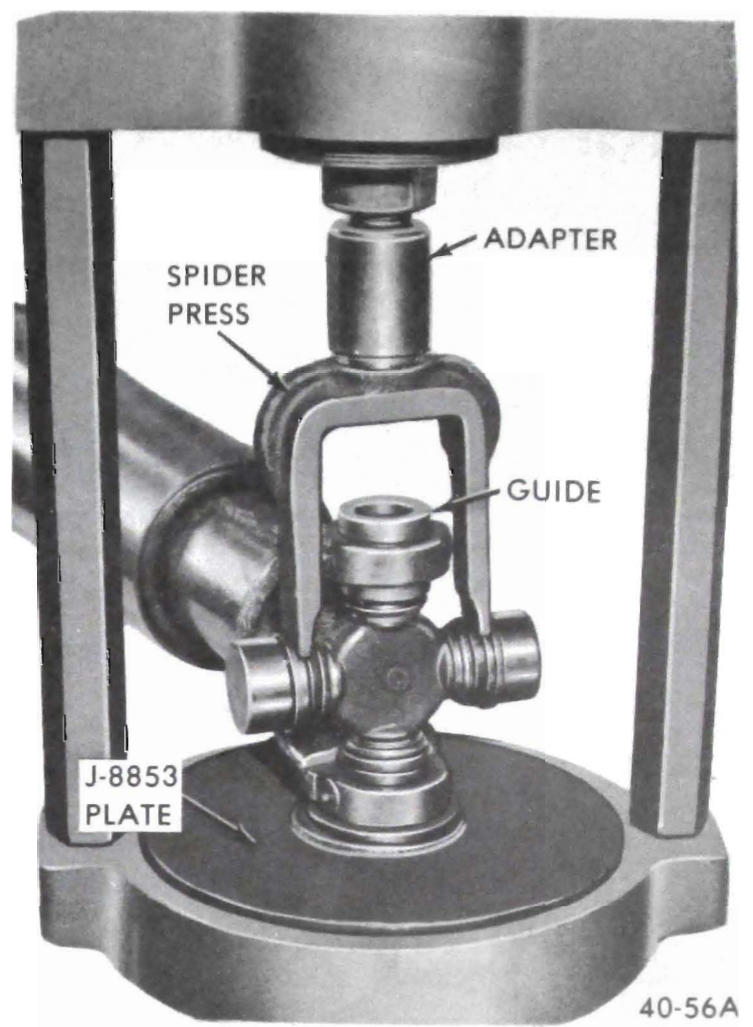
Figure 40-61 - Pressing Out U-Joint Bearing With Guide Installed

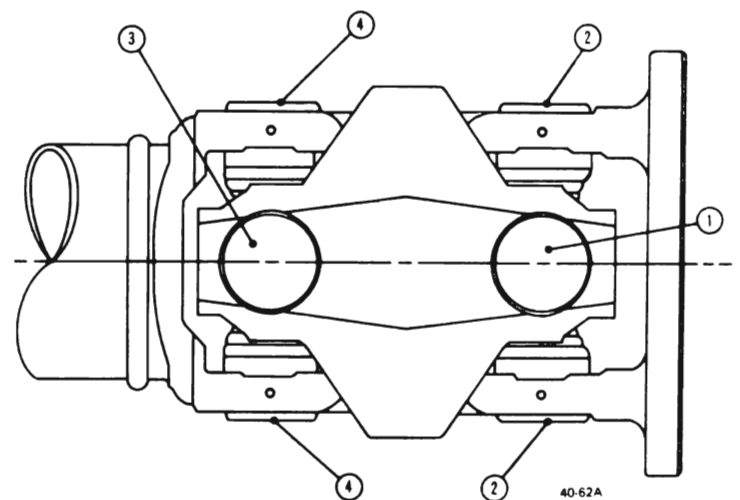
Figure 40-62 Bearing Cap Removal Sequence

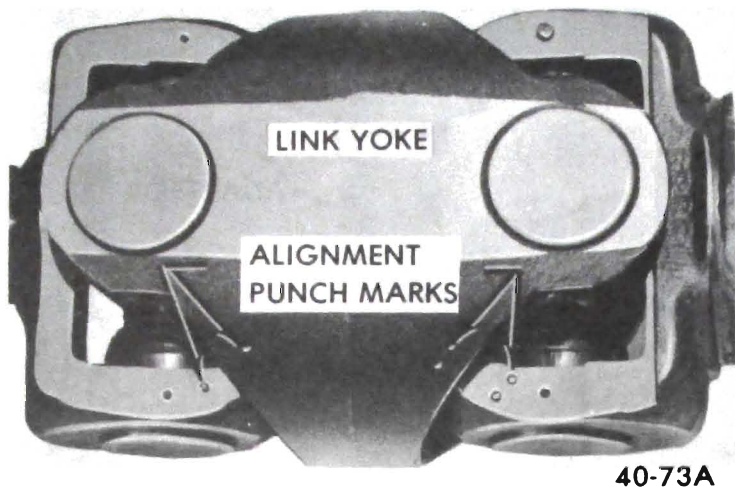
Figure 40-63 Link Yoke Showing Alignment Punch Marks

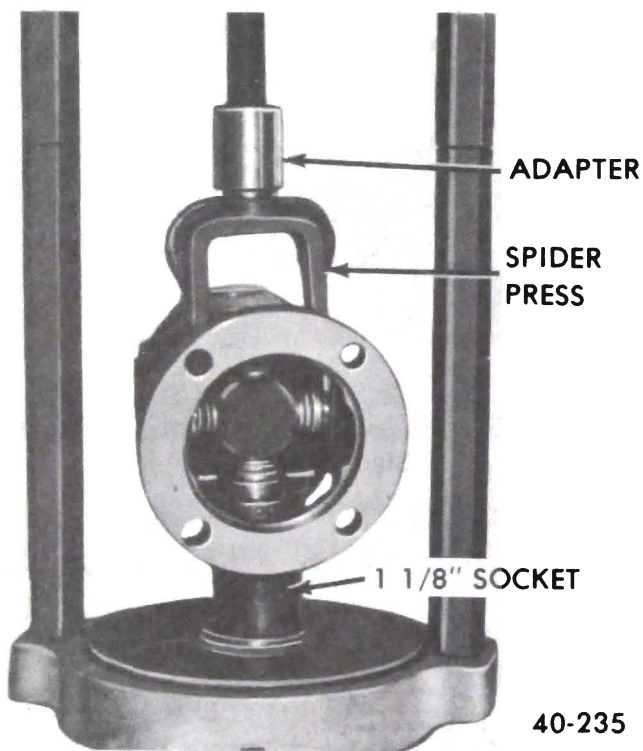
Figure 40-64 Disassembling Rear Double Cardan U-Joint

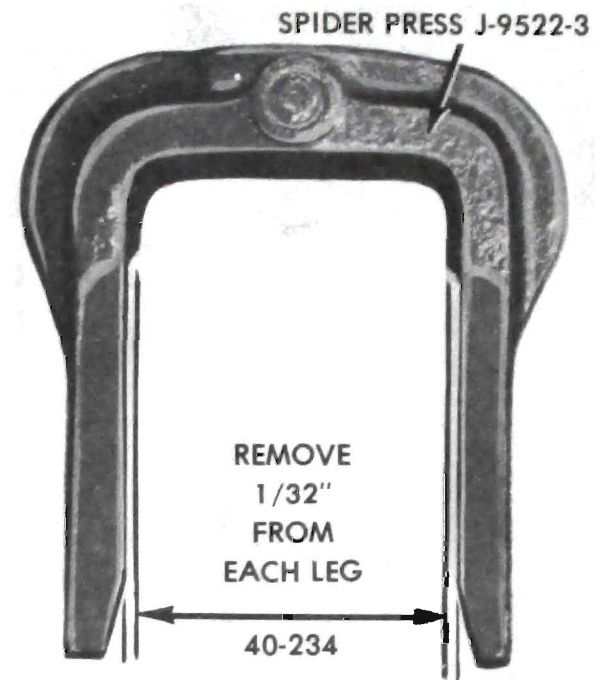
Figure 40-65 Spider Press Leg Rework

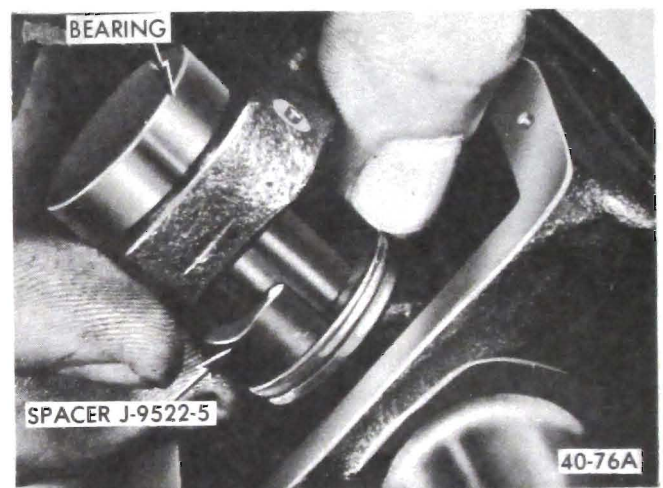
Figure 40-66 Installing Spacer

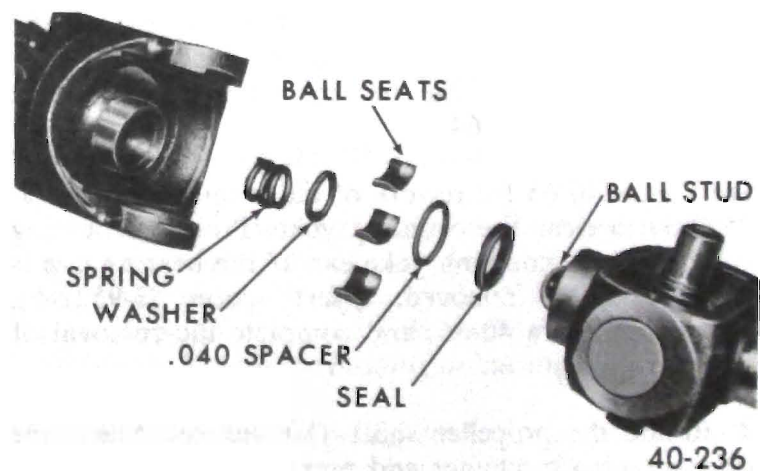
Figure 40-67 Ball Stud Seat - Exploded View

6. Pry the seal from the ball cavity, remove washers, spring, and three shoes, as shown in Figure 40-67.

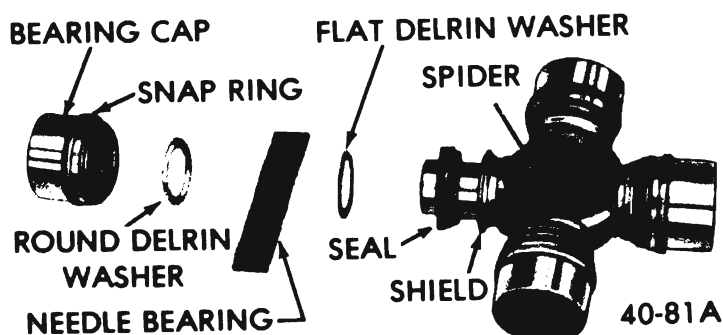
Figure 40-68 - Service Universal Joint

When reassembling a propeller shaft, install complete universal joint repair kits. Repair kits are listed in the Buick Master Parts Catalog under Group 5.442 and include a spider, four bearing assemblies, four delrin spacers, four seals and four shields. The four bearings come equipped with snap rings. See Figure 40-68.

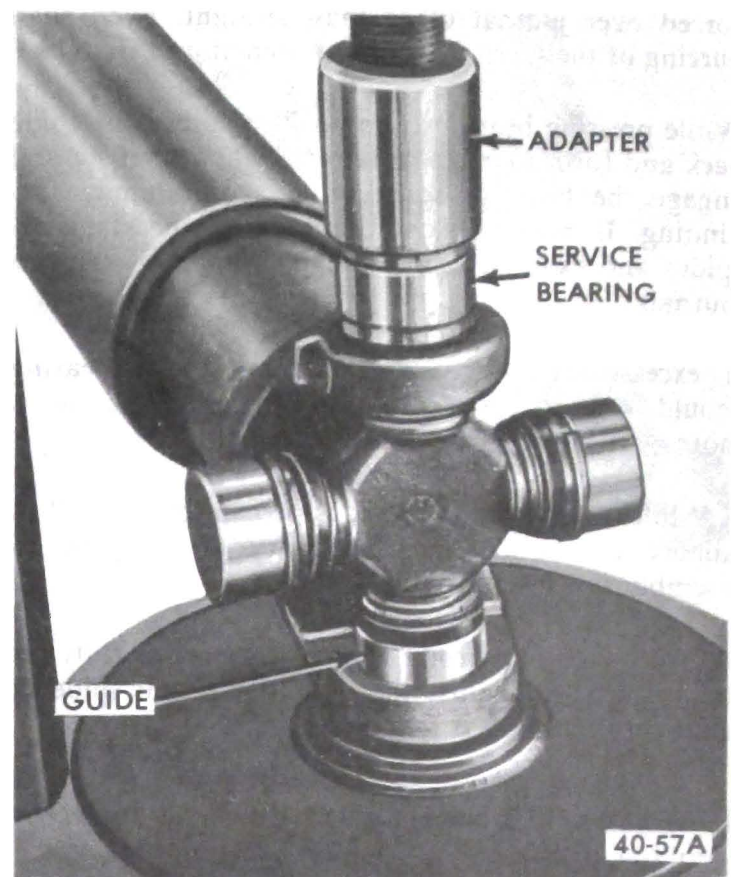
Figure 40-69 - Installing U-Joint Bearing With Guide in Place.

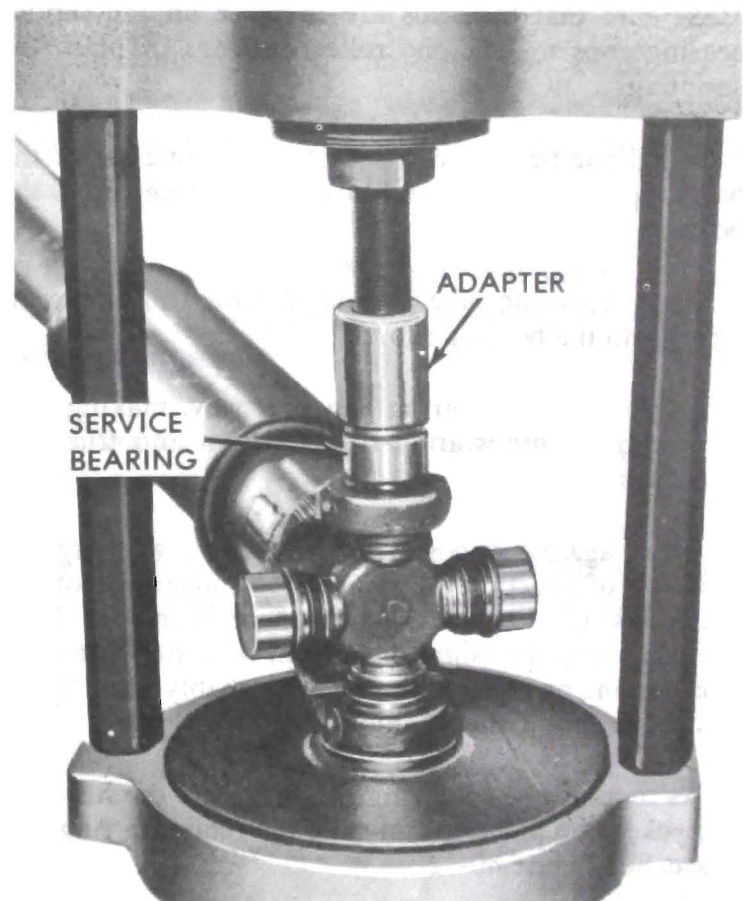
Figure 40-70 - Installing U-Joint Bearing

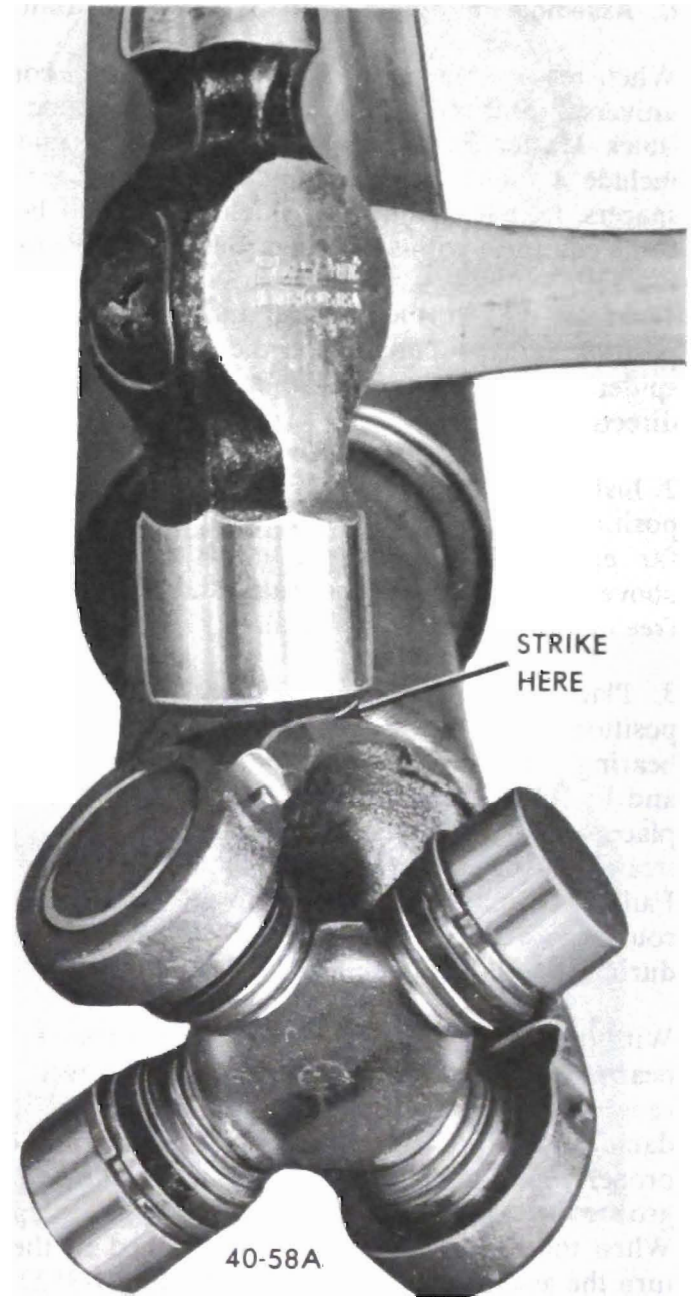
Figure 40-71 Seating U-joint Snap Rings

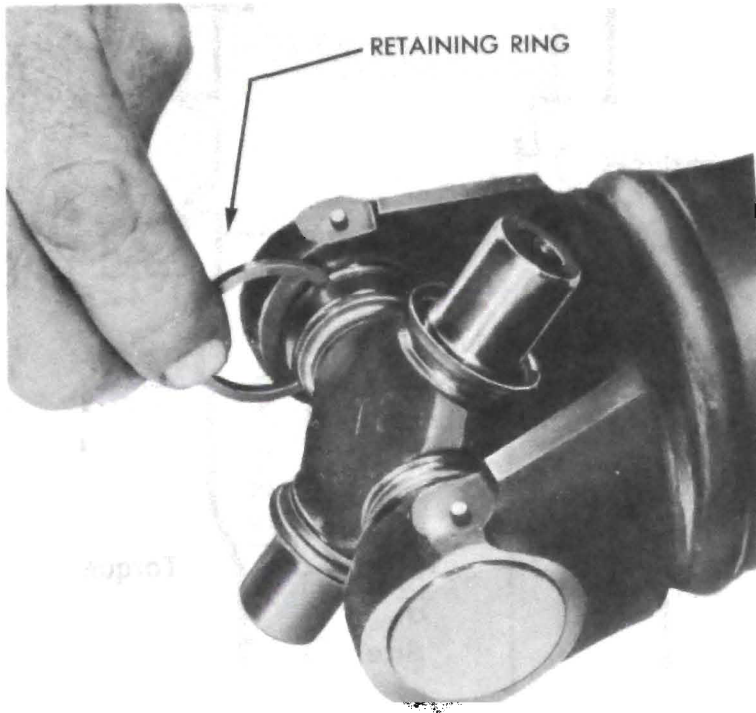
Figure 40-72 Installing Retaining Ring

5. As soon as one snap ring groove clears the inside of the yoke, stop pressing and snap the retaining ring into place. See Figure 40-72.

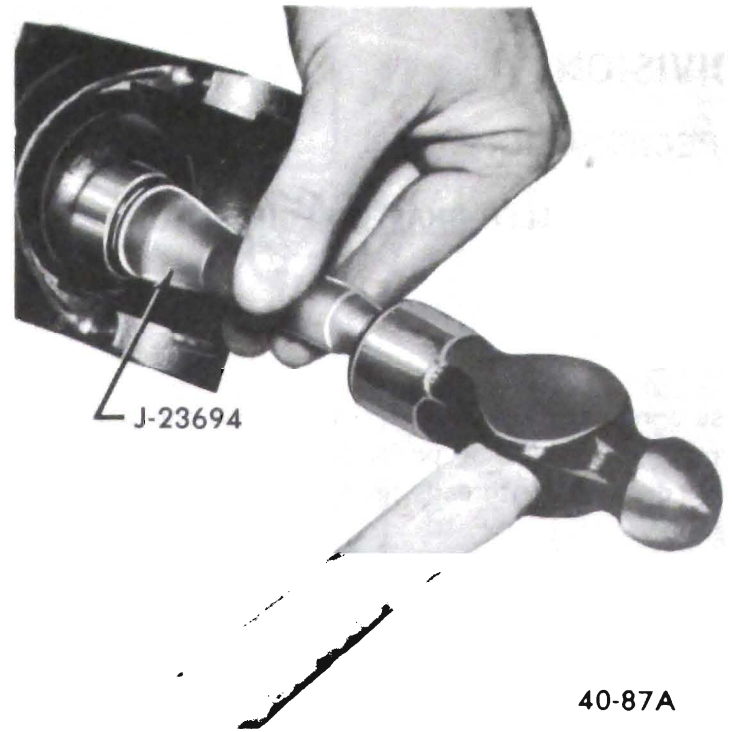
Figure 40-74 Installing Ball Stud Seal

J-23694. The sealing lip should tip inward. See Figure 40-74.

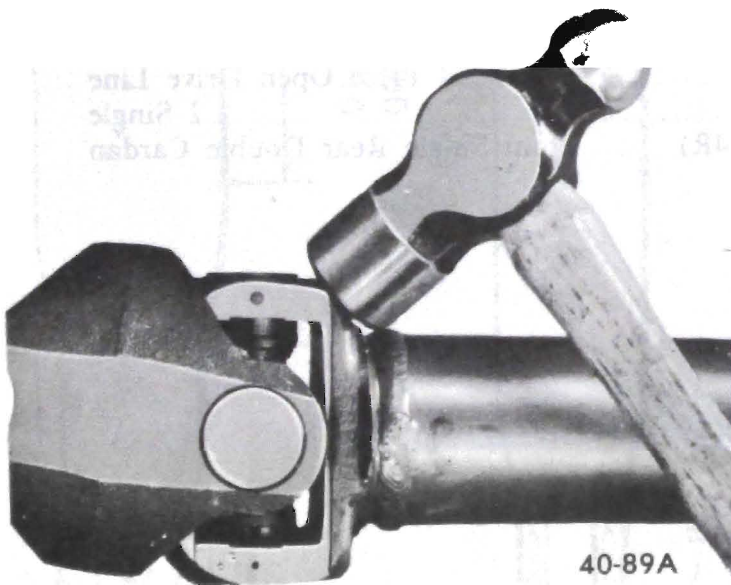
Figure 40-73 Seating Snap Ring

6. Continue to press until the opposite retaining ring can be snapped into place. If difficulty is encountered, strike the yoke sharply with a hammer to aid in seating the rings. See Figure 40-73.
