PROPELLER SHAFT

ALL SERIES

4A-12 1973 BUICK SERVICE MANUAL

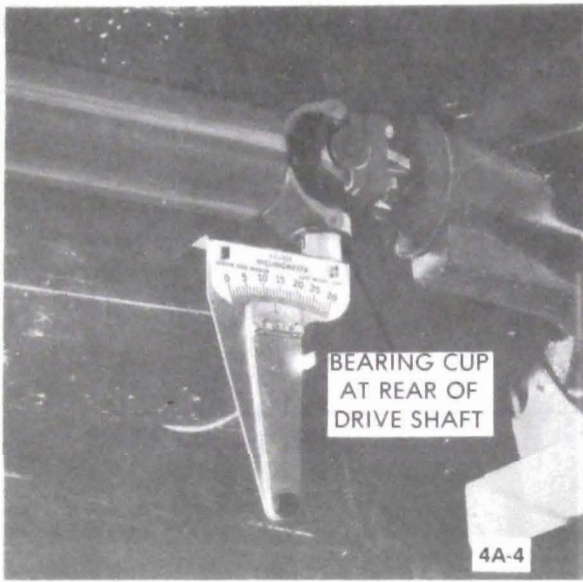
Figure 4A-4 Measuring Angle at Rear of Propeller Shaft

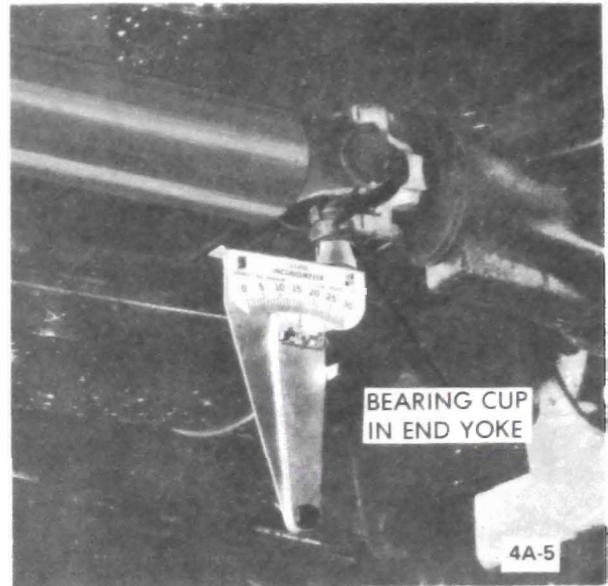
Figure 4A-5 Measuring Angle at Rear of Propeller Shaft

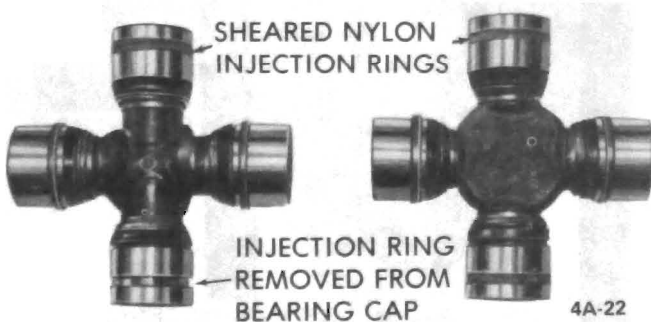
Figure 4A-22 - Production Universal Joints

When disassembling a propeller shaft, one or both of the two types of universal joints, as shown in Figure 4A-22, may be found.

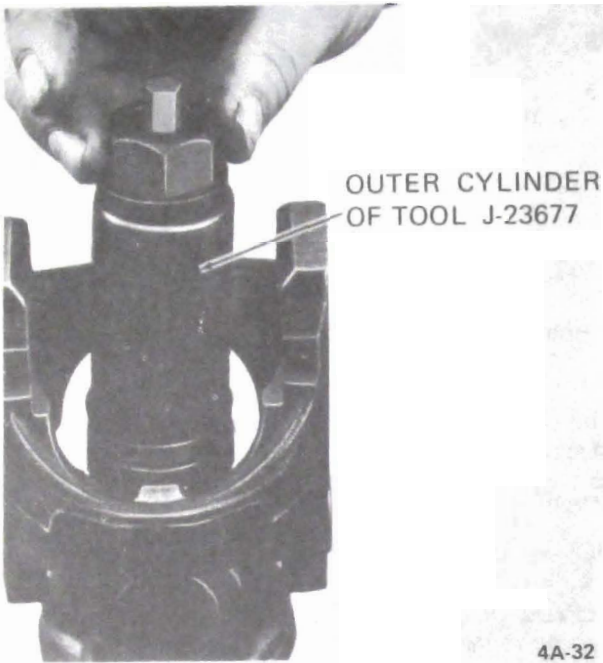
Figure 4A-32 Second Step - Removing Centering Ball with Tool J-23677

B. Place outer cylinder of Tool J-23677 over outside of ball. See Figure 4A-32.

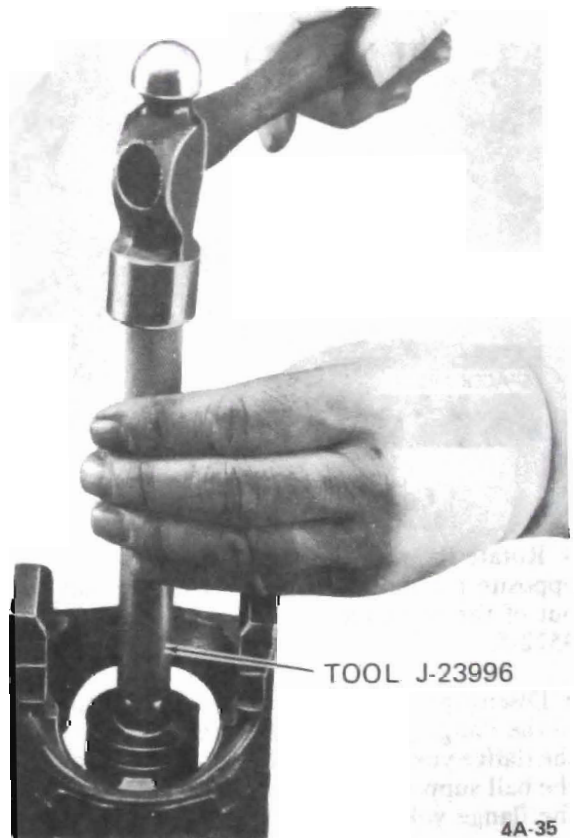
Figure 4A-35 Installing Ball Using Tool J-23996

E. Using Tool J-23996 drive ball onto stud. See Figure 4A-35. Drive until ball can be seen to seat firmly against shoulder at base of stud.
